A Forest Stewardship Plan for the Property of Alana Ennis

Prepared by Richard Sanders, NCRF #1564

January, 2013

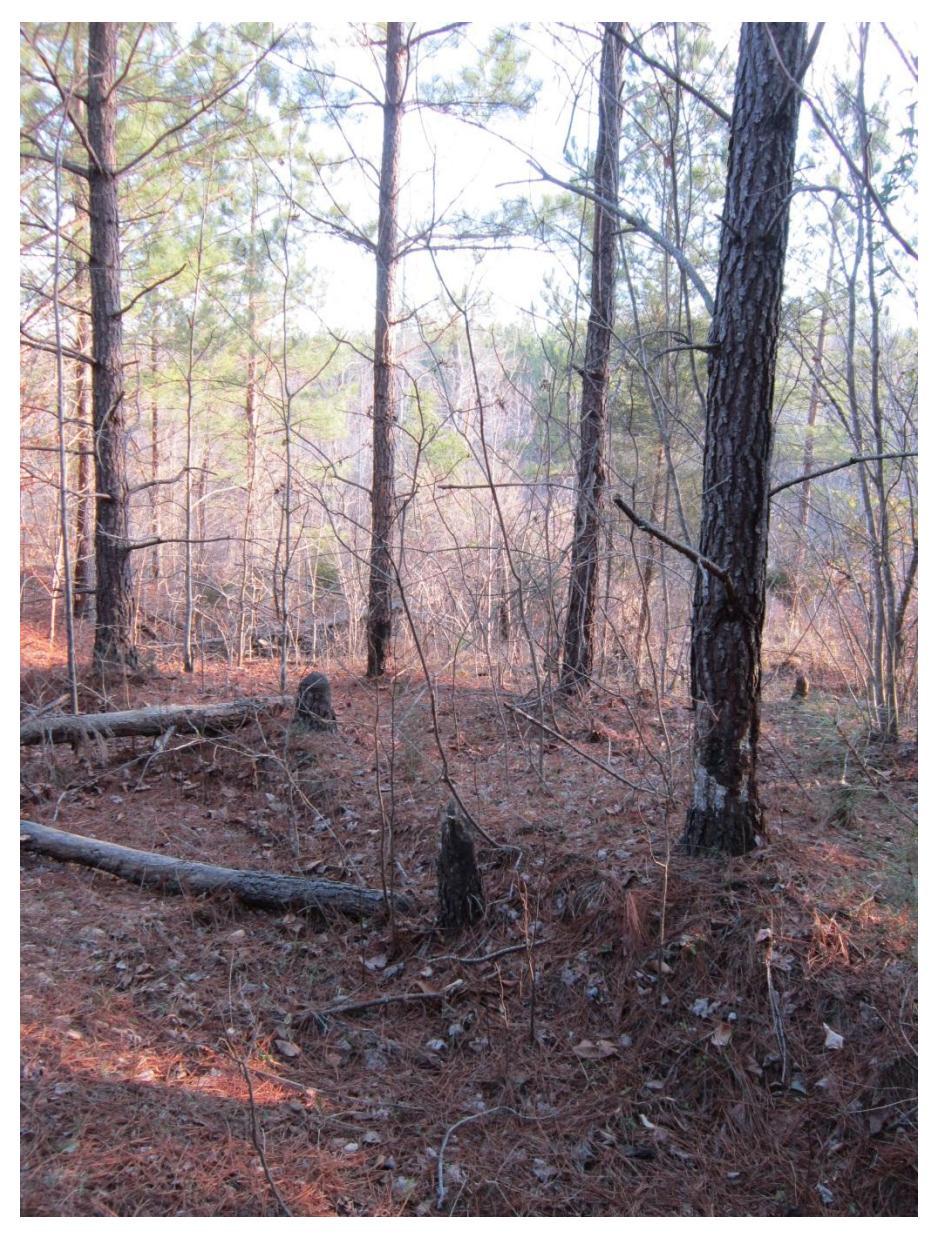
Some damage to the pine stems on the southern boundary has occurred from the beaver populations in Stand 7. See Figure 1

Figure 1: Beaver damage on southern edge of Stand 1

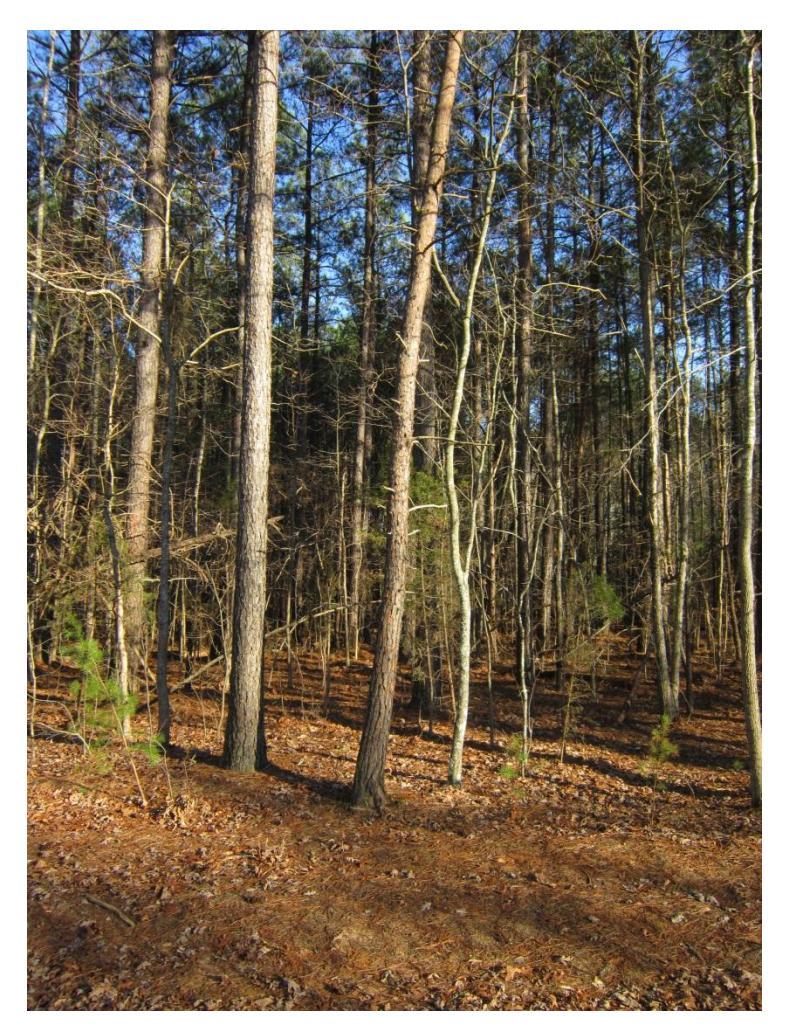
The stand is composed of two separate age classes of pine, but should be managed as one unit in the future. The northern portion is about thirty five year old planted loblolly that has never been thinned. The southern portion is about fifty years old and established on old fields, but was not cut during the last harvest. Diameters in the younger trees are between 7 and 16 inches and the older trees are between 14 and 20 inches. Understory and mid story hardwoods include red maple, sourwood, sweetgum, and tulip poplar.

Figure 2: Stand 6 needs thinning

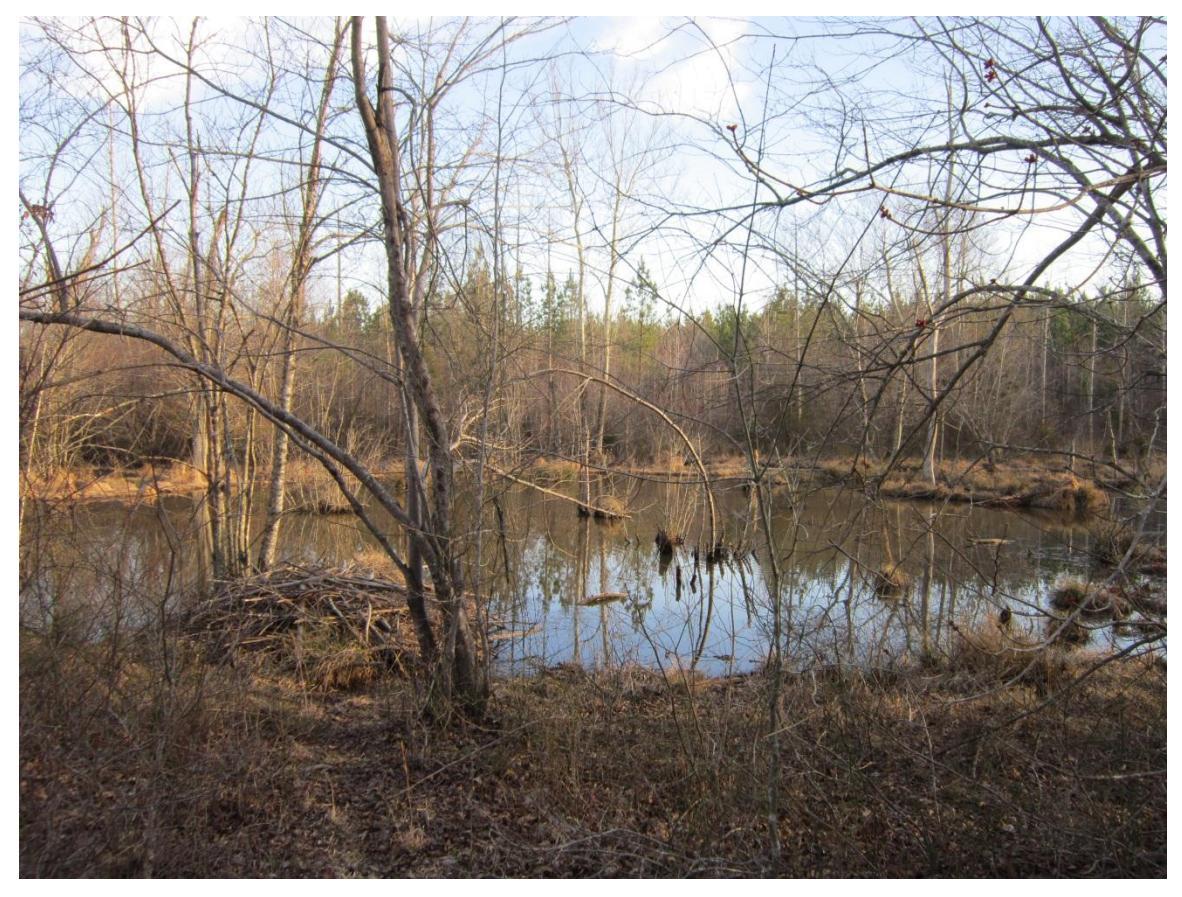
The beaver population in this stand is high and these animals are a major force of change here, actively expanding their territory and changing the vegetation and hydrology. Ponds, active and abandoned, are present throughout the stand (see figure 3 below). The active ponds are providing excellent habitat for waterfowl, fish, reptiles and amphibians. The abandoned ponds are becoming re-vegetated with diverse early successional wetland plant species and providing a unique cover type on the property, used by a wide variety of animal species.

Figure 3: Active beaver pond, lodge in front left

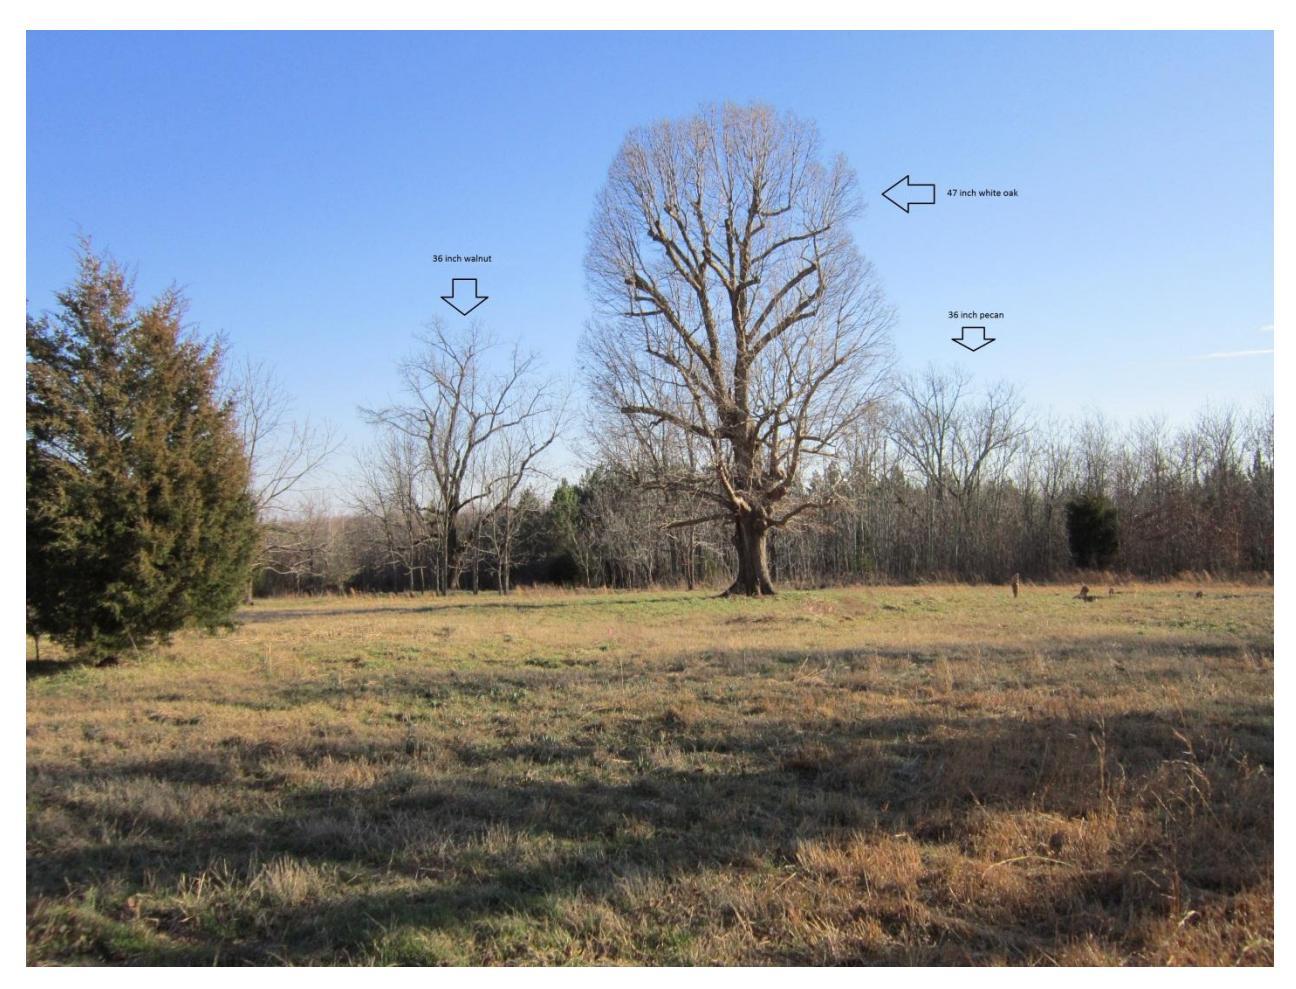
b. This 0.9 acre area encompasses the southern portion of the old homesite. The location is relatively high and dry and centrally located. Several scattered older opencrown trees cover the majority of this area, including a 47 inch white oak, a 36 inch pecan with a large spreading crown, and a 36 in black walnut. Under the larger trees, a dense stand of tree-of-heaven has developed as well as smaller walnuts and pecans.

Figure 4: Stand 8b, large mast producers over tree-of-heaven midstory

The tree-of-heaven here needs to be removed. Mechanical removal of trees and stumps followed by frequent mowing would be effective if the area will be closely monitored and managed in the future. Otherwise, a cut stump treatment with a triclopyr based herbicide should be considered. This work will greatly improve the aesthetics in this highly visible area, preserve the integrity of the remains of the homesite, and facilitate future establishment of other productive trees and shrubs.

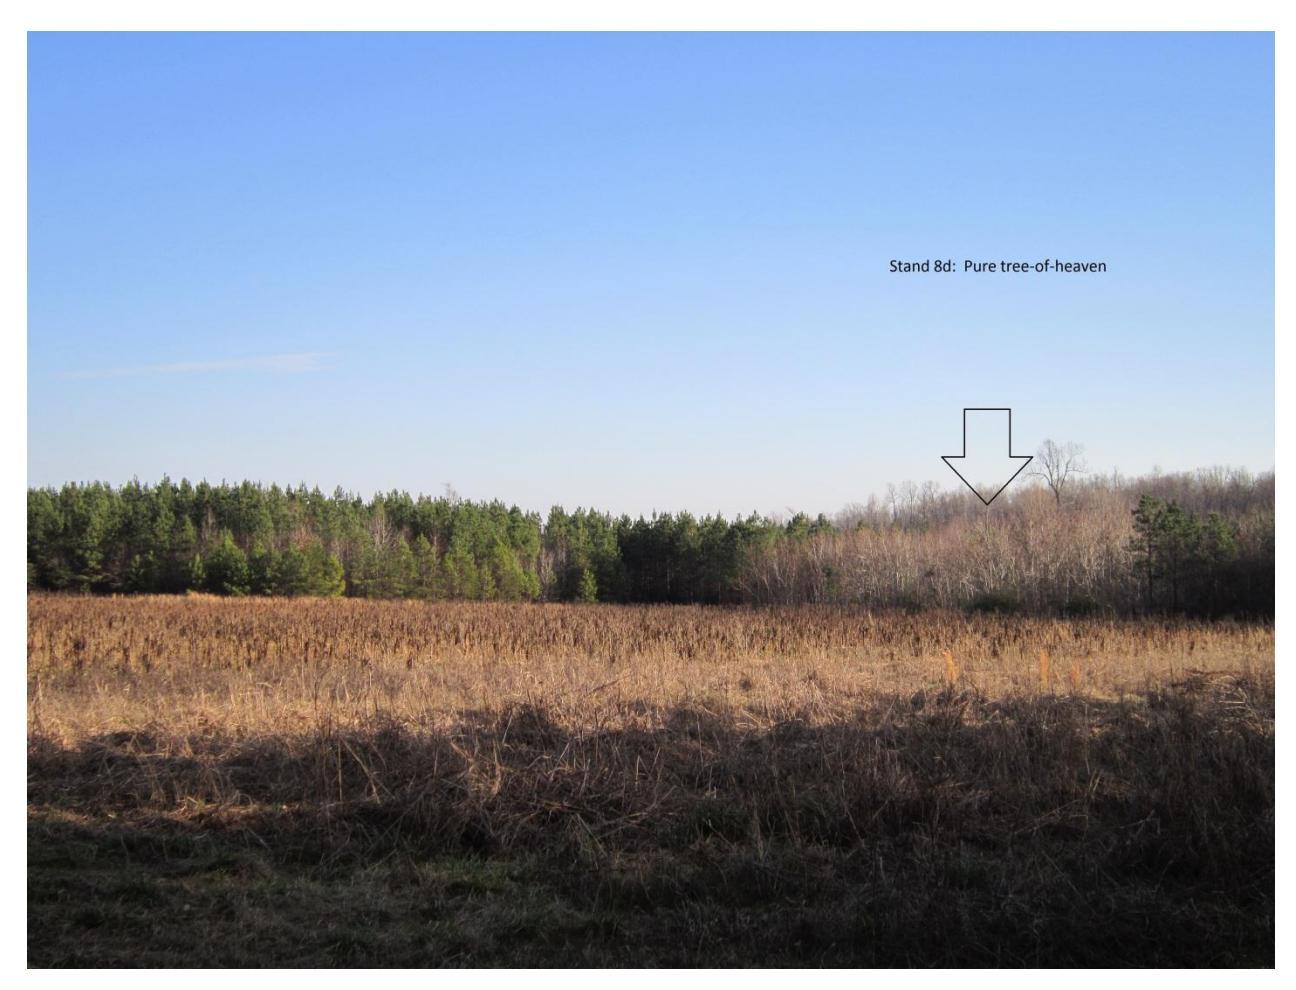
d. This is 0.2 acres of pure tree-of-heaven located on the southern edge of the cultivated field. Somewhat wetter soils, probably damaged during logging, allowed the species to quickly outcompete native tree species here after the last timber harvest.

Figure 5: Stand 8d, pure tree-of-heaven. Stand 1 back left.

Intensive management will be necessary here to eliminate the threat posed by the tree-of-heaven. Establishment of a forest garden in this area would necessitate high labor inputs early on and would allow for removal of this forest health threat while simultaneously achieving the permaculture goal.

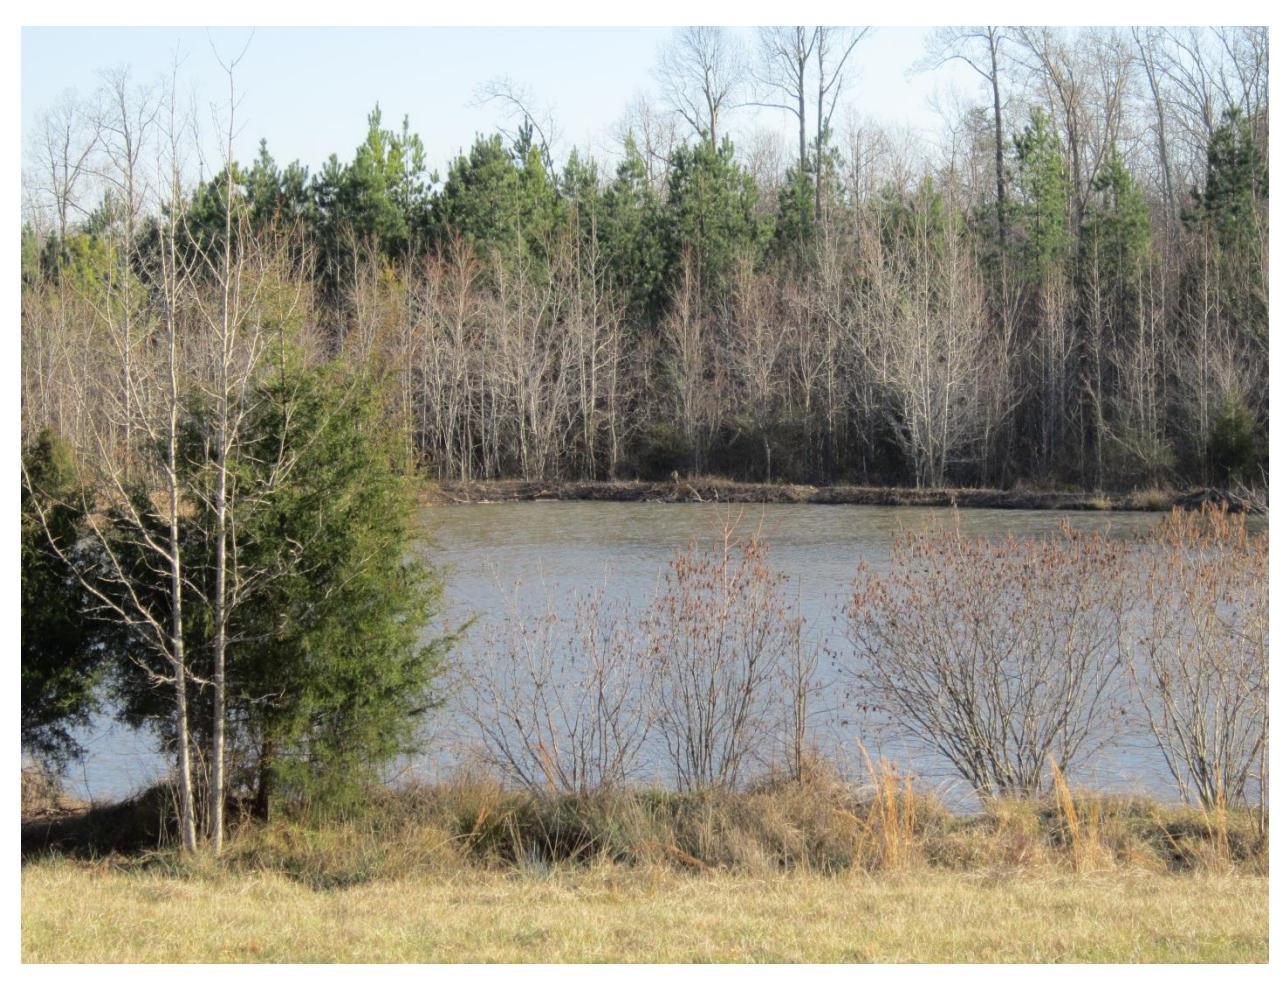
The farm pond, 2.5 acres, is a positive feature on the landscape that should be maintained and protected. Resources are available from NRCS, NC Cooperative Extension, and the NC Wildlife Resources Commission regarding management of farm ponds.

Figure 6: Farm pond with Stand 3 in background, smooth alder in right foreground
